RECLAMATION

RIVER SURVEY ON THE RIO BLANCO

PREPARED BY:
Tamara Massong and Michael Porter
Environment Division
Albuquerque Area Office

March 2006

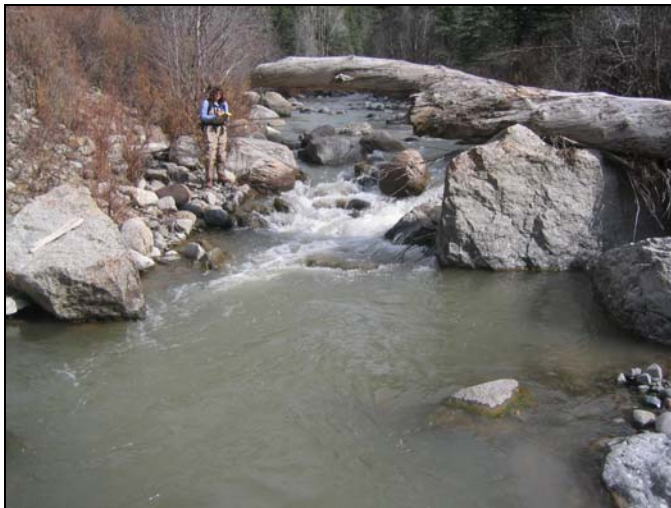
Figure 2: Large boulder forced step with downstream pool formation; Upstream Reach of the Rio Blanco about 400 meters downstream from the diversion dam.

Only 3 pools were found in the upstream reach (Figure 6), and each of these pools were forced by a very large boulder step/cascade (Figure 2). Although two pieces of woody debris were mapped in this reach, neither were influencing the low-flow channel morphology (Figure

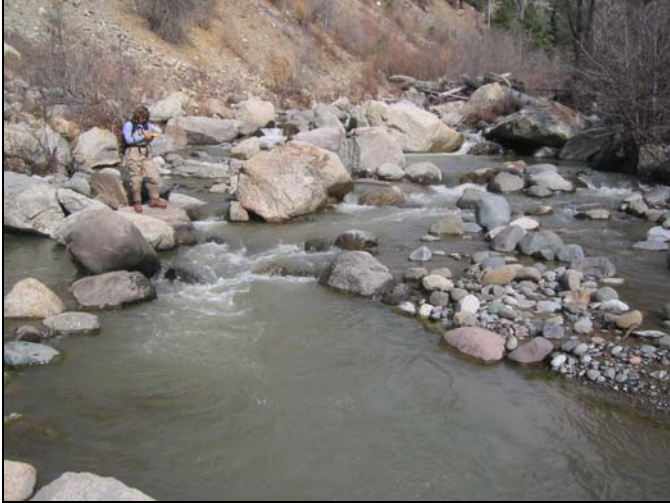
Figure 3: Small boulder steps around large boulders in the Upstream Reach of the Rio Blanco about 200 meters downstream from the diversion dam.

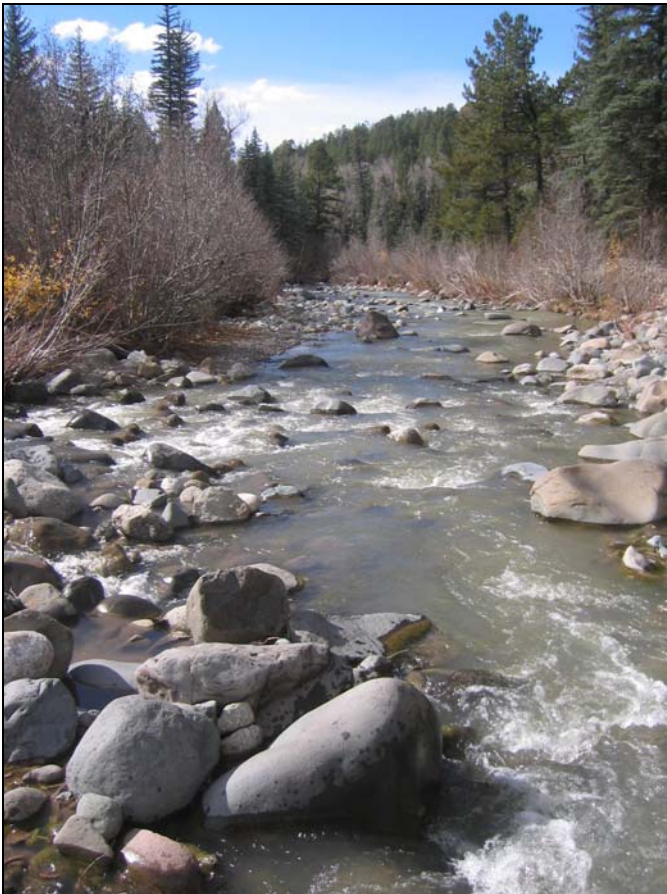
Figure 4: Medium-small boulders and cobbles in a plainbed section in the Upstream Reach of the Rio Blanco about 500 meters downstream from the diversion dam.

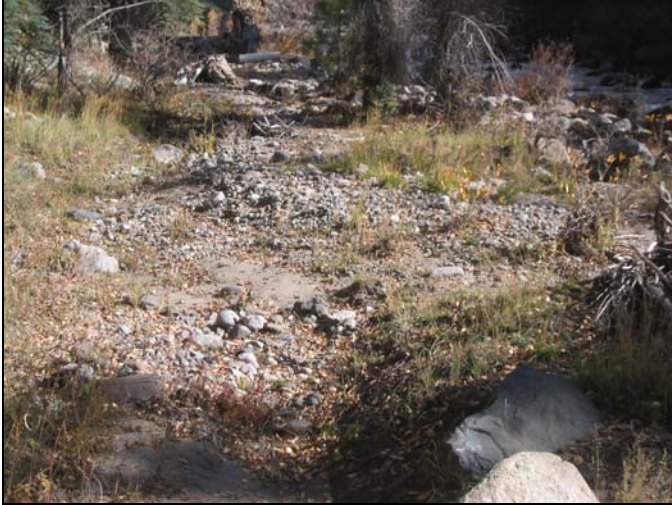
Figure 5: Gravel and cobble deposits on top of a tall bar in the Upstream Reach of the Rio Blanco.

Gravel was predominantly absent from the sediment deposits in the river channel, however some were found on top of tall bars that appear to be above the high water mark (Figure 5). The high water mark is presumably the bankfull mark from the 2005 spring runoff as the 2005 runoff event was significantly large (pers. comm. E. Olivas, October 2005). Finer grained sediment, such as sand and silt, was completely absent in this reach of river.

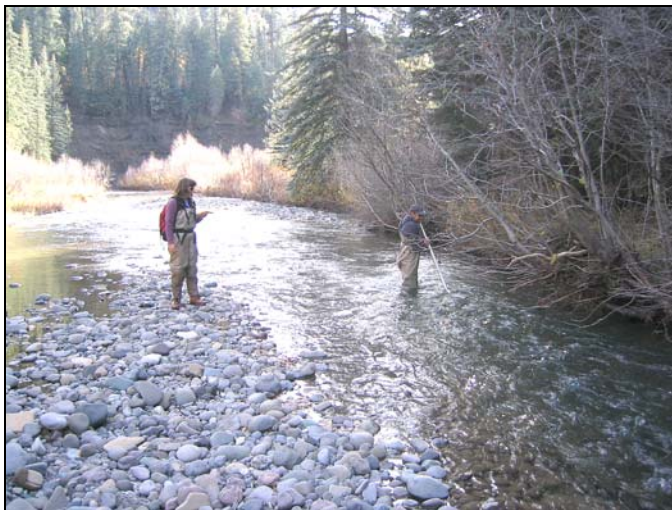
Figure 7: Shallow pool in the Downstream Reach on the Rio Blanco.

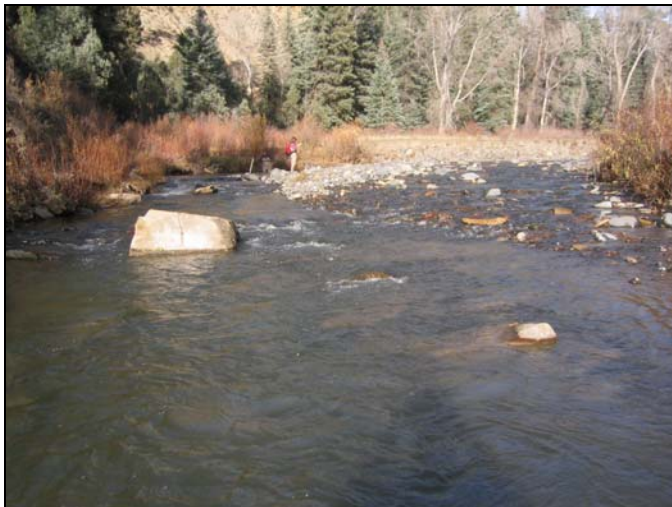
Figure 8: Split channel (braid) with downstream plainbed section; Downstream Reach on the Rio Blanco.

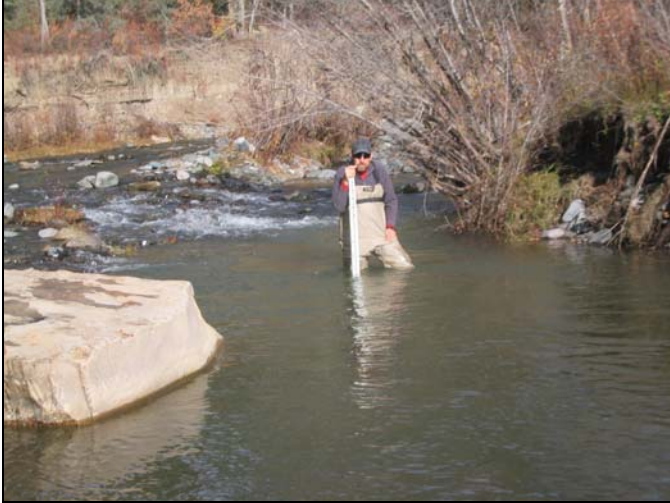
Figure 9: Channel-spanning alluvial pool (bank forced) with steep riffle immediately upstream of the pool; Downstream Reach on the Rio Blanco.

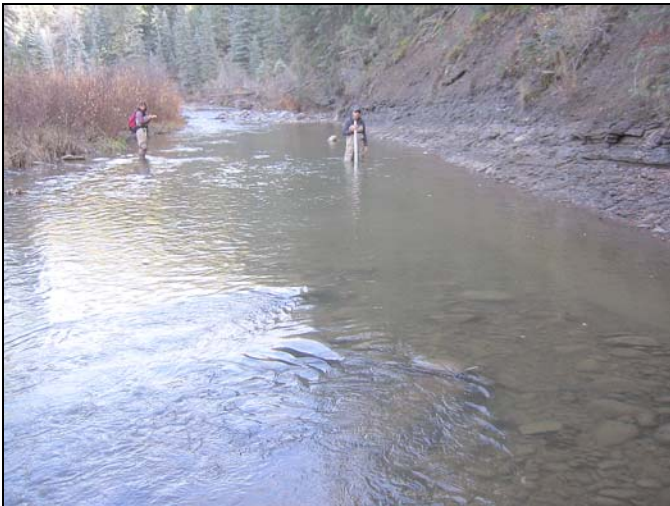
Figure 10: Valley wall forced, long, deep bedrock pool; Downstream Reach on the Rio Blanco.

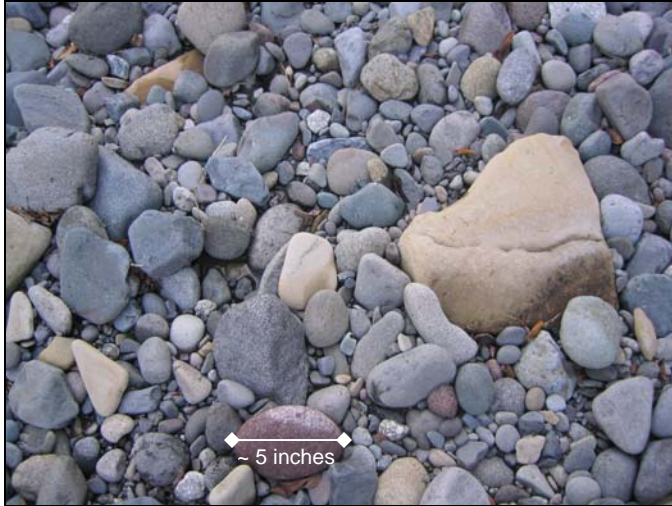
The sediment within the low-flow channel, which is mostly cobbles and boulders, is coarser than that found on the exposed bar surfaces. The bars consist primarily of cobbles and very coarse gravel (Figure 11), with some small boulders. Although pebble counts were not conducted, the plainbed sections contained sediment noticeably larger than that found in the riffles; the plainbed sections contained more boulders than observed in the riffles. Gravel is present in this reach, however, large patches of gravel were limited to hydraulic shadow zones (sheltered areas); the most common of these features ($n=7$) were log jams or woody debris (Figure 12).

Figure 11: Picture of cobbles and very coarse gravel deposited on a point bar; Downstream Reach on the Rio Blanco.
